County of Santa Cruz

Santa Cruz Veterans Memorial Building Repair Project

Attachment 1 is a report detailing preliminary findings of the seismic evaluation from the Streeter Group and William Fisher Architect. This evaluation supports their original opinion that the building represents a risk to occupants during a seismic event. The report identifies structural deficiencies that do not meet minimum life safety performance standards, in particular the requirement that the lateral force resisting system have a complete load path to resist seismic loads (meaning that every element which resists seismic loads from the roof down to the foundation is adequately fastened together). In addition to the structural findings, preliminary recommendations are made for repairing the identified deficiencies. Additional geotechnical and materials testing work is still underway and is expected to be available before the end of the month at the latest, which may necessitate an update to the anticipated repair strategy.

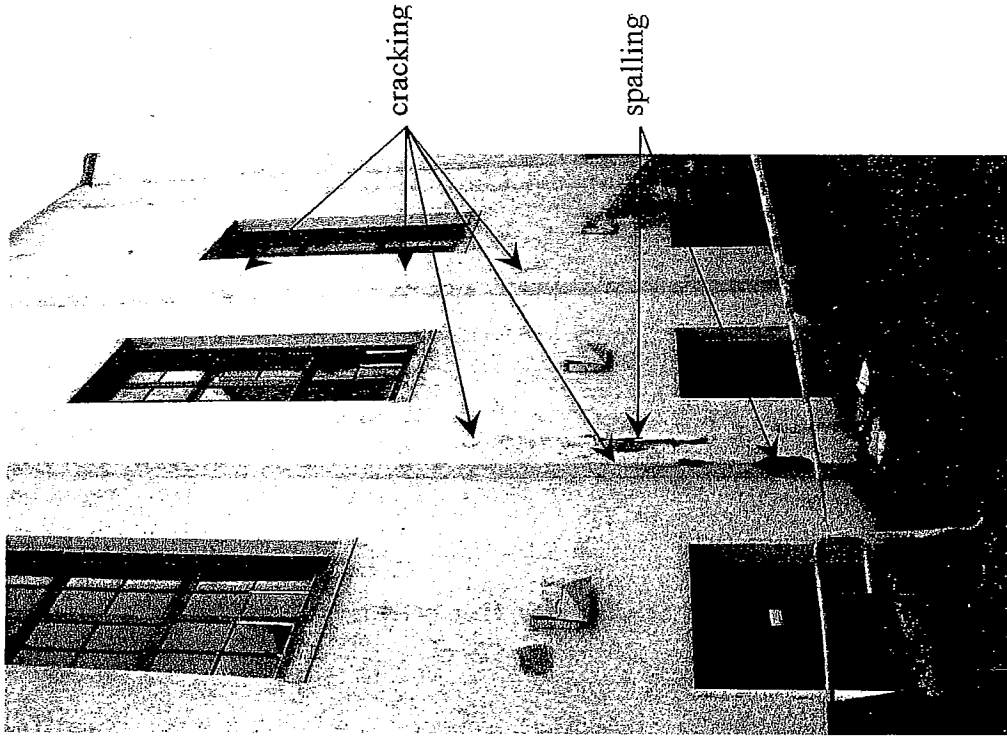
Photo 4

- Roof diaphragm connection to the perimeter concrete shear walls. Visible gaps with no connection are visible between perimeter roof rafter / ledger and concrete walls. See photos one and two.
- Lack of connection of roof diaphragm to shear wall along grid six.
- Lack of positive connection between shear walls as load is transferred through floor framing along grid 6.
- **Deterioration of Concrete:** Exterior skin of the concrete has spalled in several locations due to corrosion of reinforcing steel. See photos three through eight, eleven and twelve.

SPALLING OF CONCRETE AT PILASTER

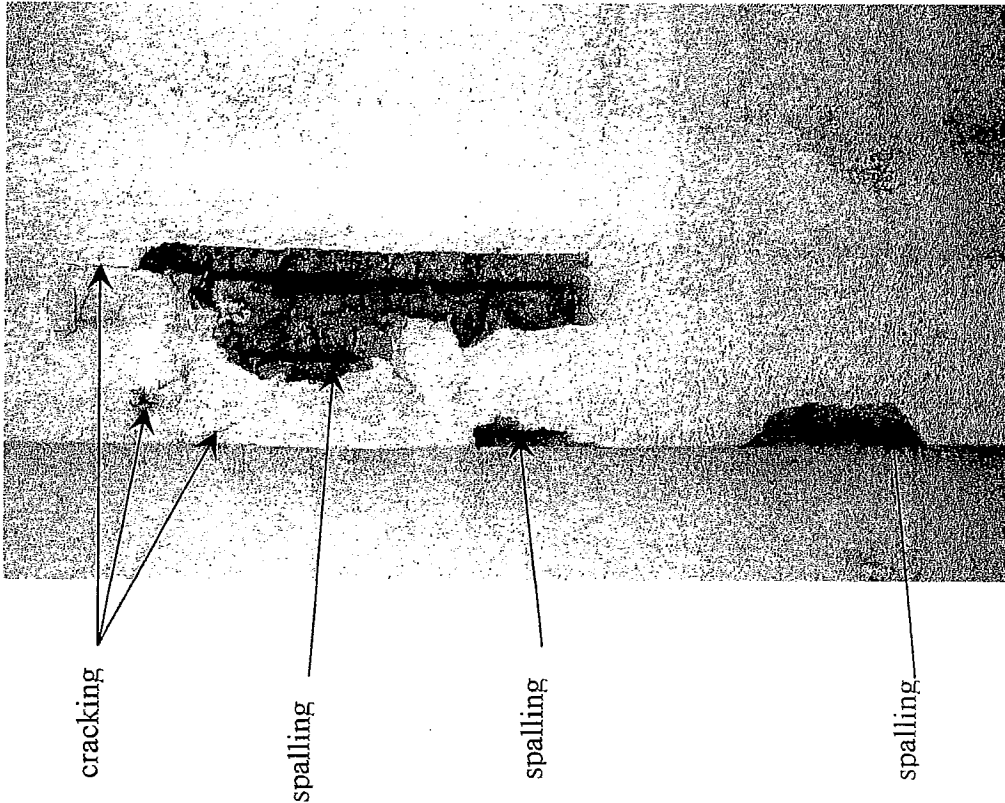
Photo 3

SPALLING OF CONCRETE AT PILASTER

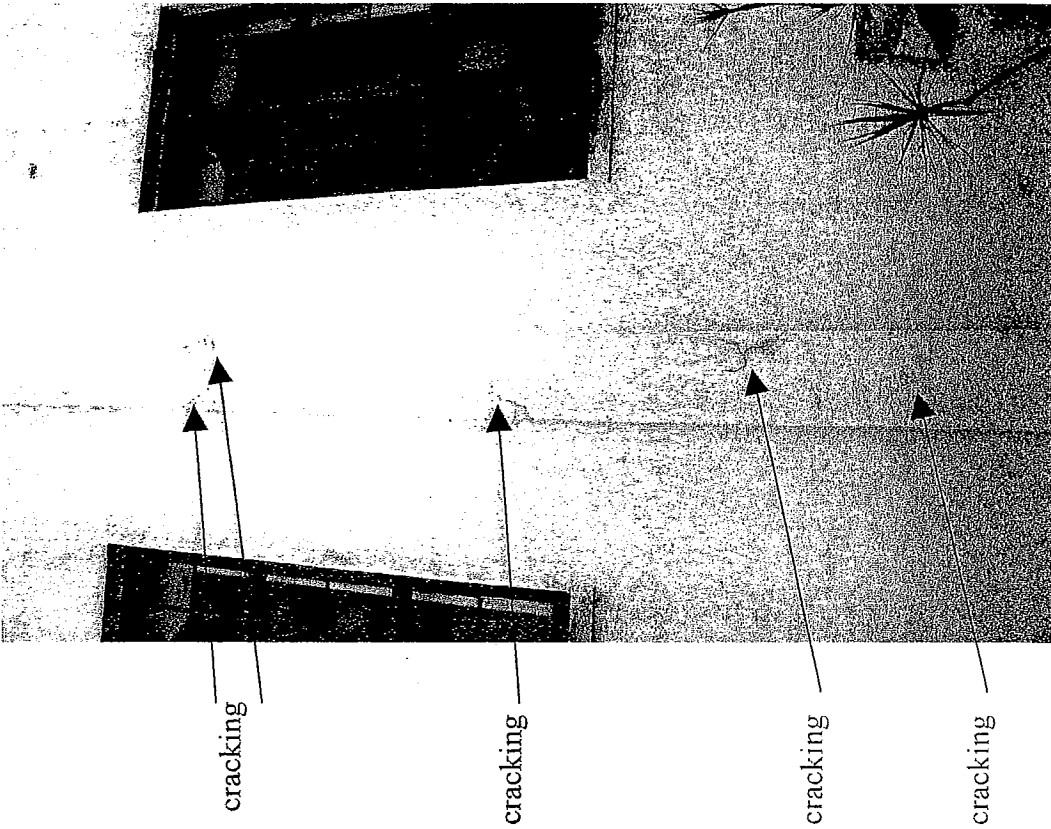
CRACKING OF CONCRETE AT PILASTER
Photo 5

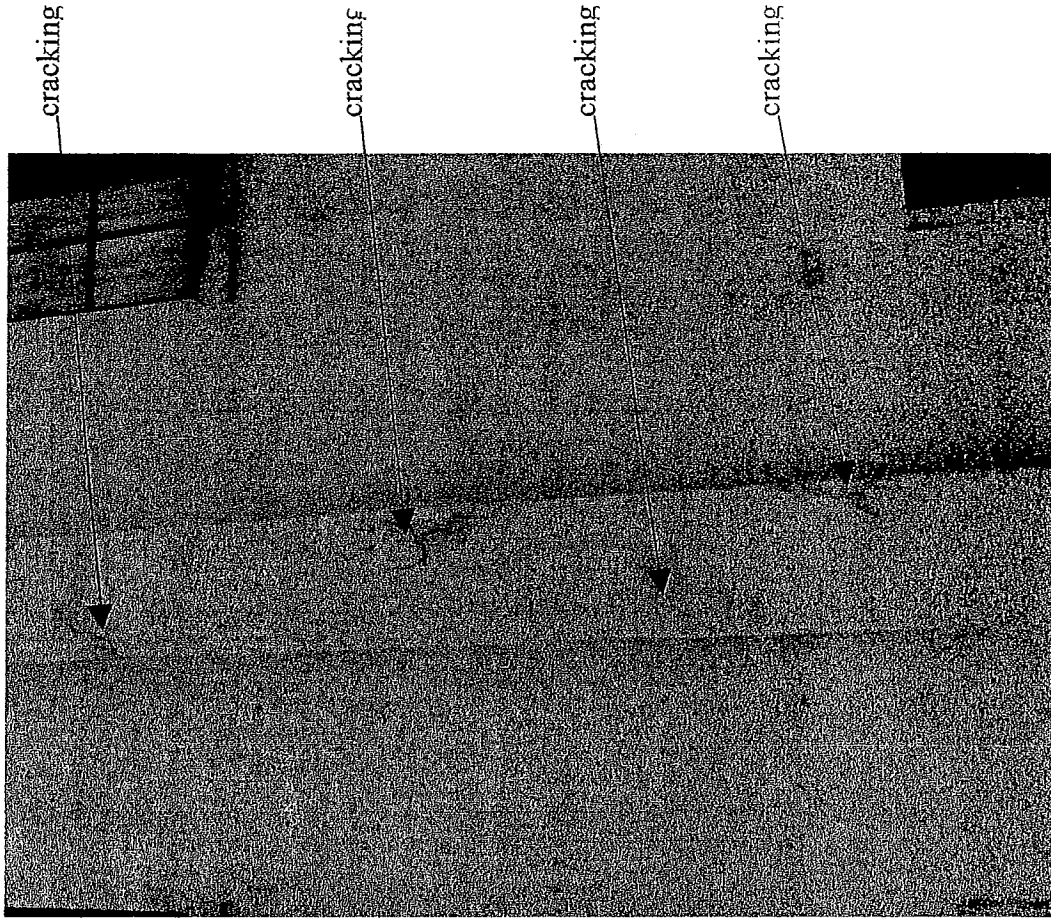
CRACKING OF CONCRETE AT PILASTER
Photo 6

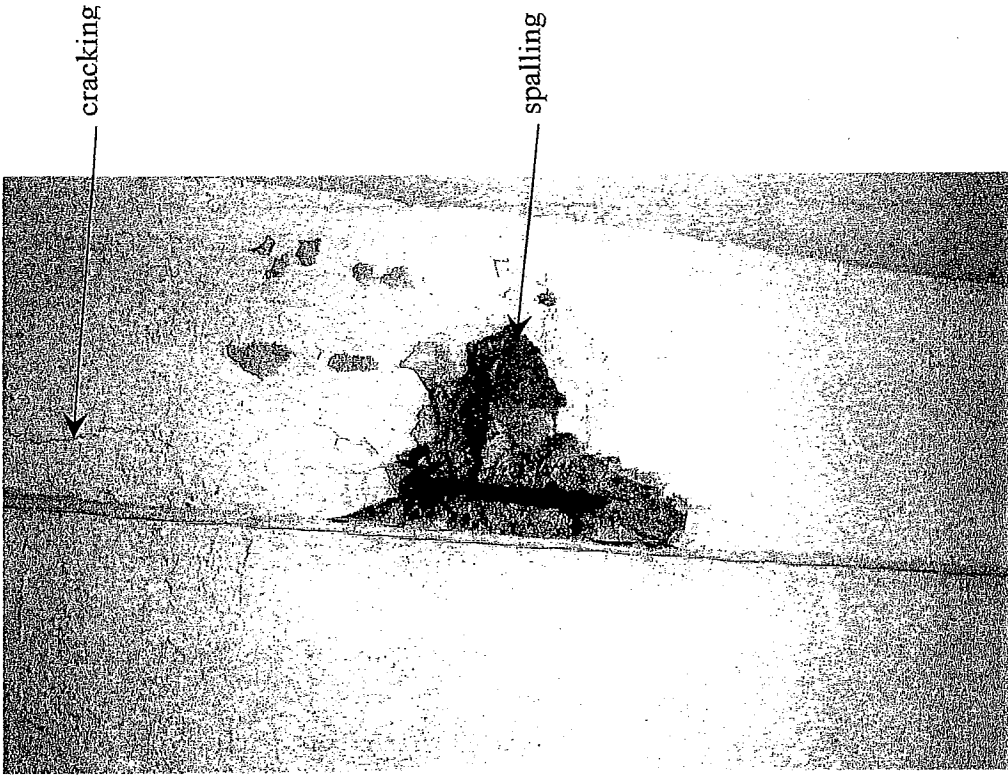
SPALLING OF CONCRETE AT PILASTER
Photo 8

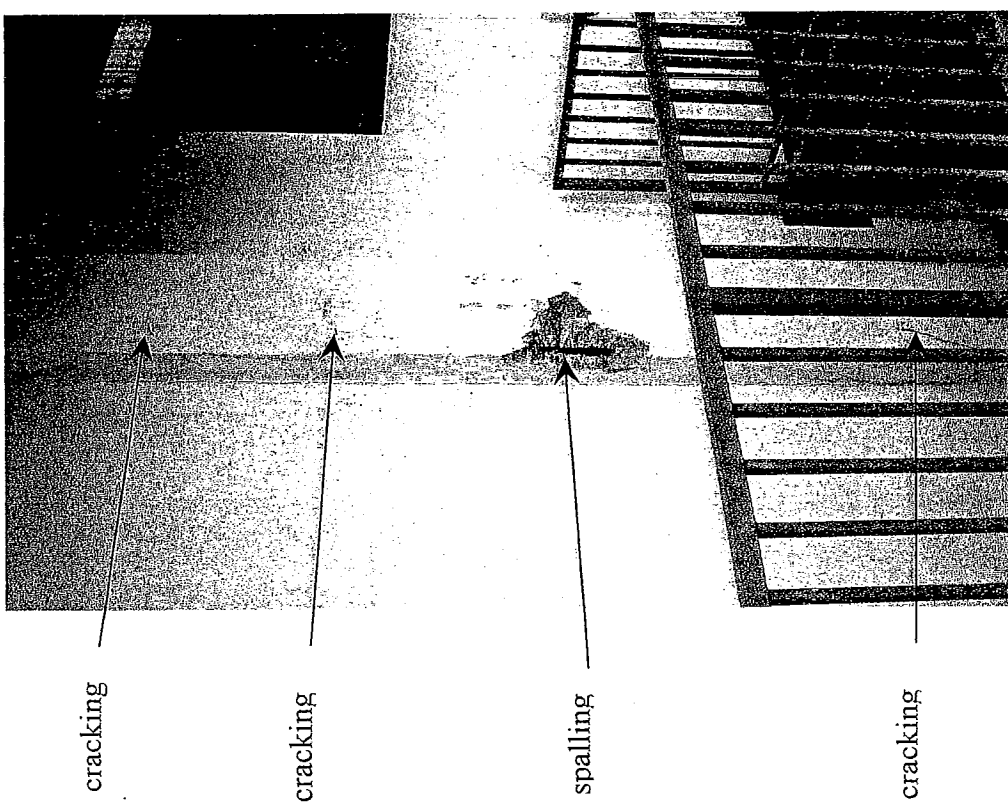
SPALLING OF CONCRETE AT PILASTER
Photo 7

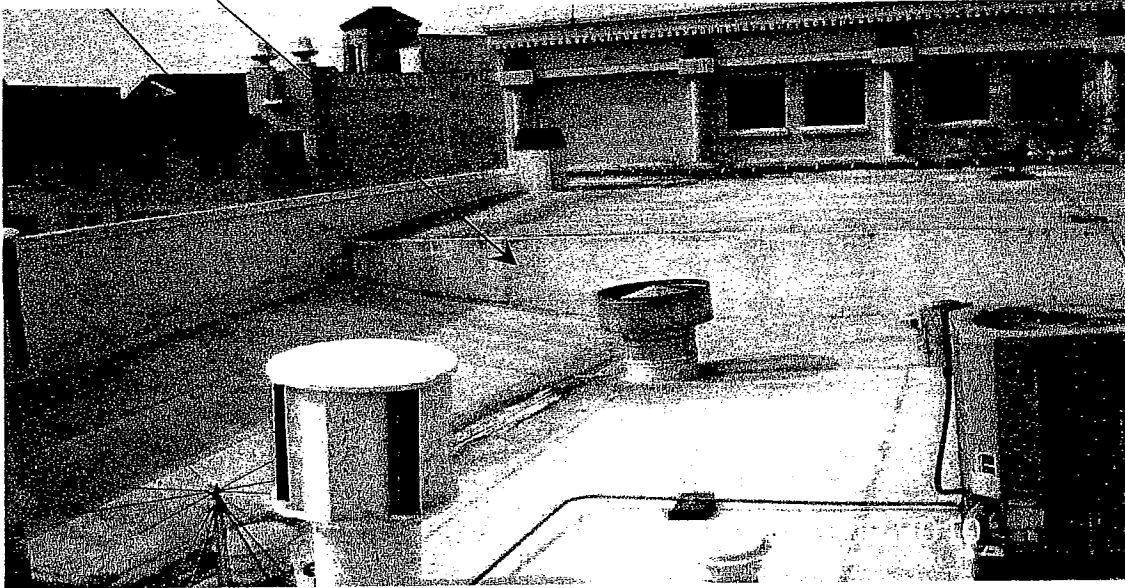
Photo 9

- Diaphragm Continuity: Roof diaphragm steps in elevation at grids three and six. Diaphragm shear transfer not observed at these locations. See photos nine and ten of stepped roof condition.
- Cross Ties: In general the original engineer of the building appears to have attempted to tie the building together rather well with the following exception. No exterior wall to roof connection tie is noted on the plans along grid A. Additional inspection required.
- Spans: Existing roof diaphragm consists of straight sheathing. Straight-sheathed diaphragms are flexible and weak relative to other types of diaphragms. Tier two analysis indicates that the existing roof diaphragm is inadequate.

Step in roof diaphragm
at Grid 3

STEP IN ROOF DIAPHRAGM

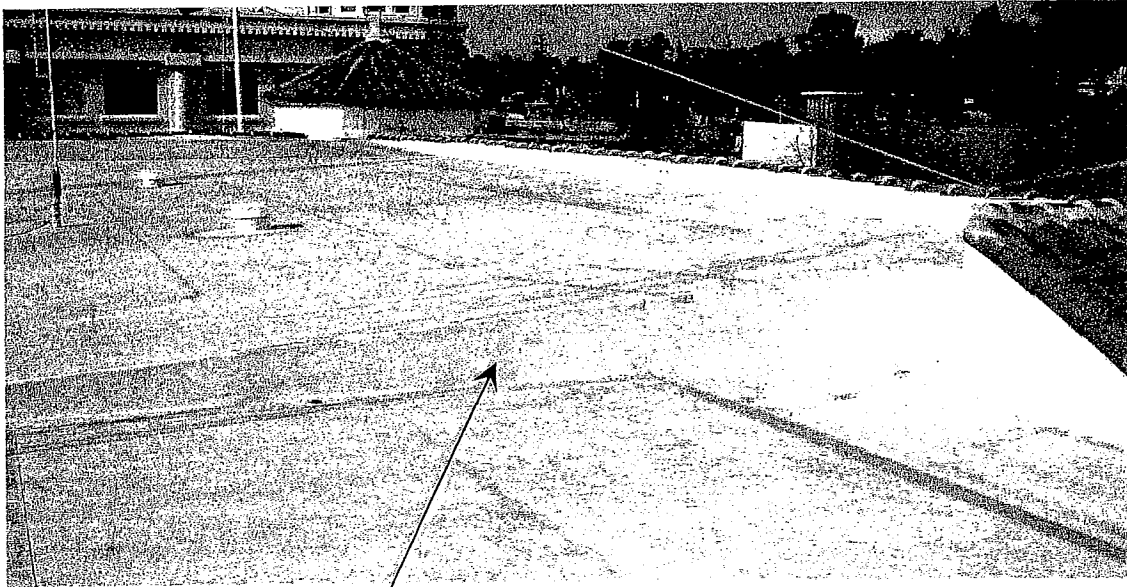
Photo 10

Step in roof diaphragm
at Grid 6

STEP IN ROOF DIAPHRAGM

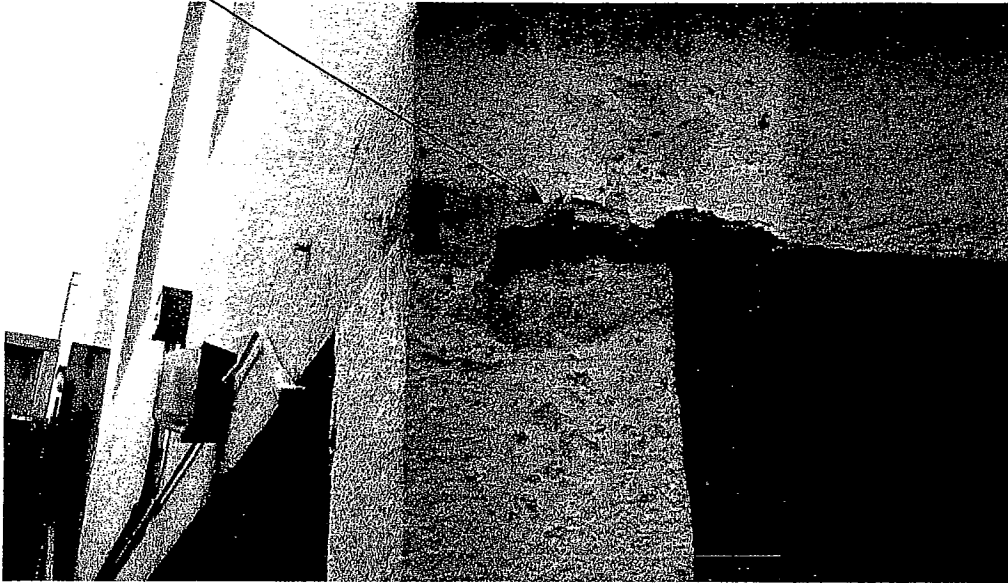
Photo 11

Concrete Spalling

STAGE ADDITION CONCRETE COLUMN SPALLING

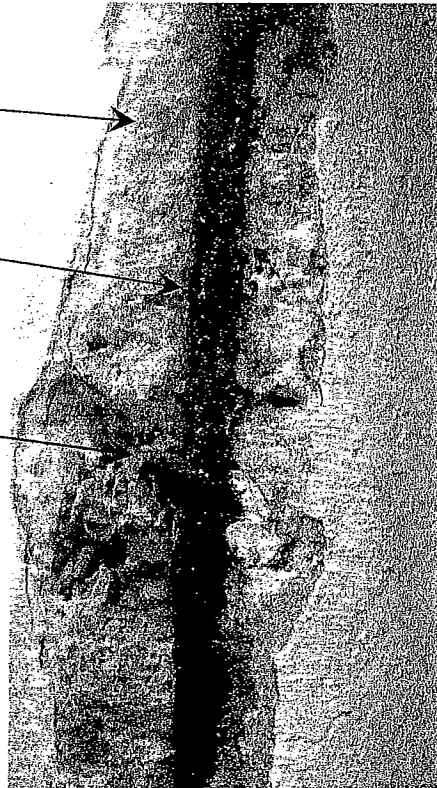
Photo 12

Concrete Spalling

Corrosion of Vertical
Reinforcement

Corrosion of
Horizontal
Reinforcement

STAGE ADDITION CONCRETE COLUMN
SPALLING AND REINFORCEMENT CORROSION
