**SANTA CRUZ COUNTY
BOARD OF SUPERVISORS INDEX SHEET**

Creation Date: 4/7/10
Source Code: GENSV
Agenda Date: 4/13/10
INVENUM: 63685

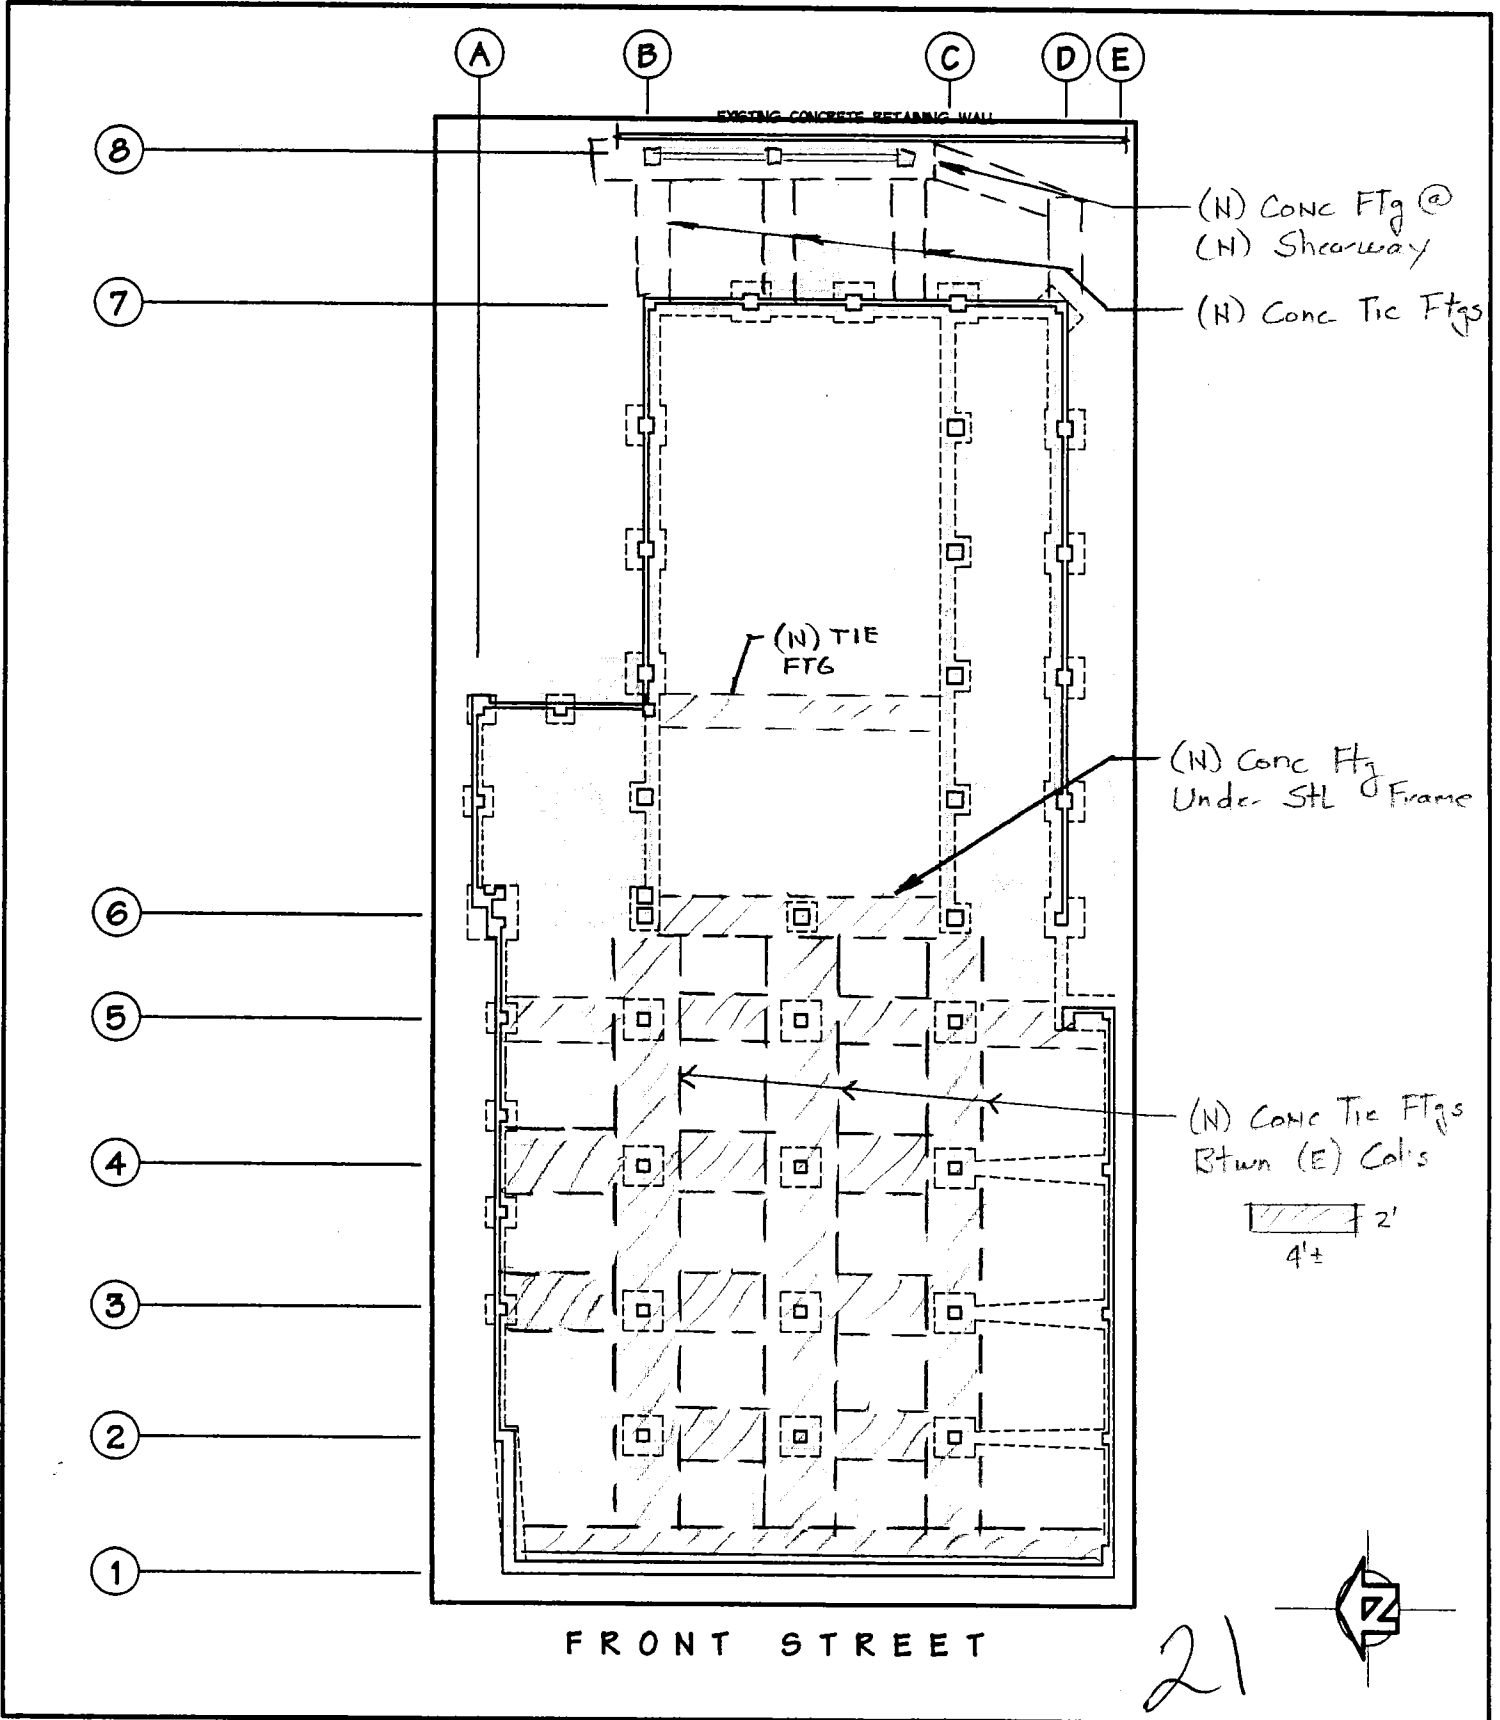
JOB 10C - Veterans Hall
SHEET NO. Partial Foundation Plan
CALCULATED BY _____ DATE _____
CHECKED BY _____ DATE _____
SCALE _____

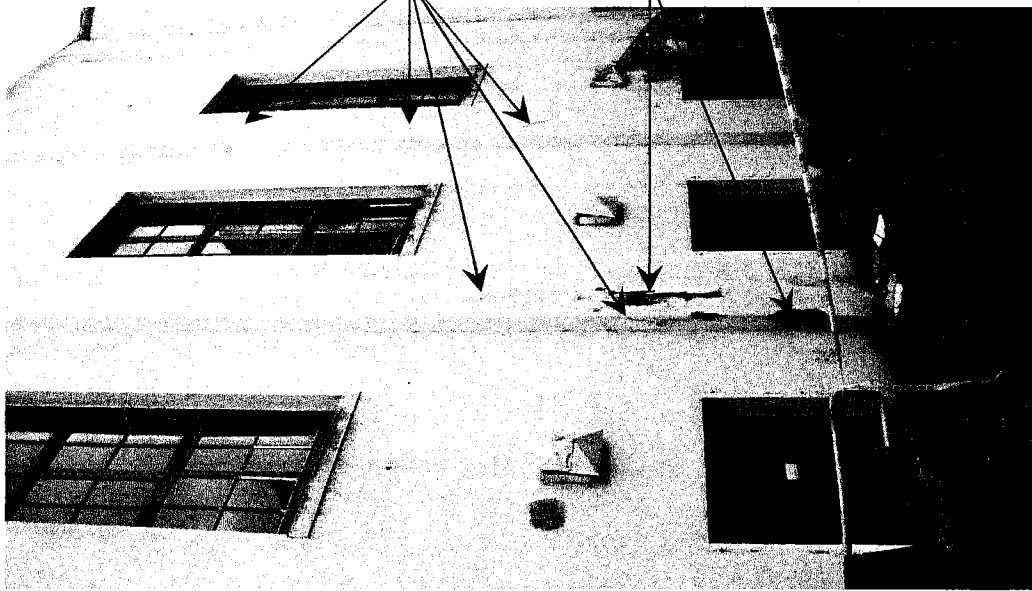
SPALLING OF CONCRETE AT PILASTER

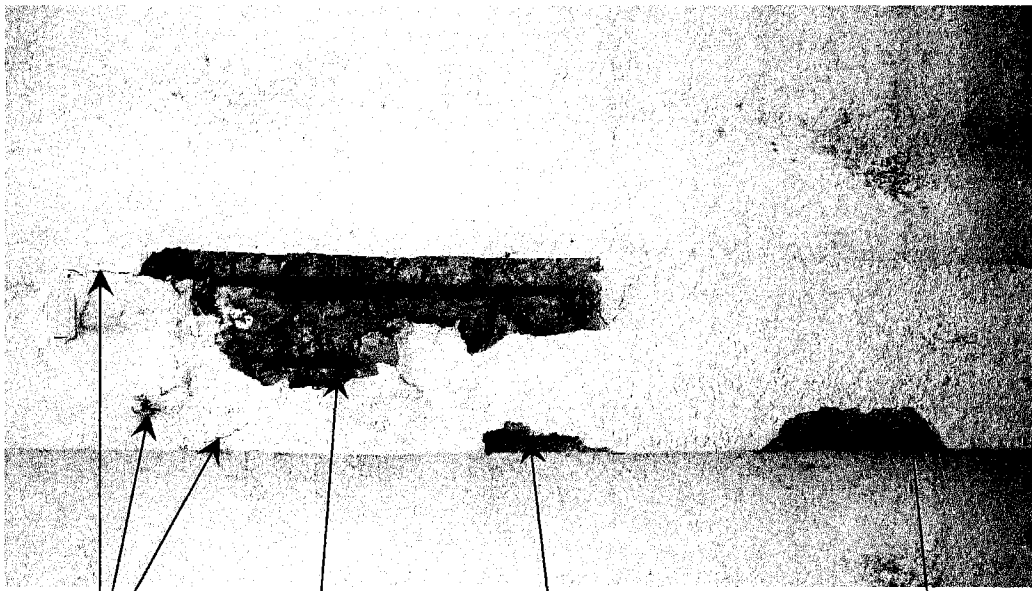
SPALLING OF CONCRETE AT PILASTER

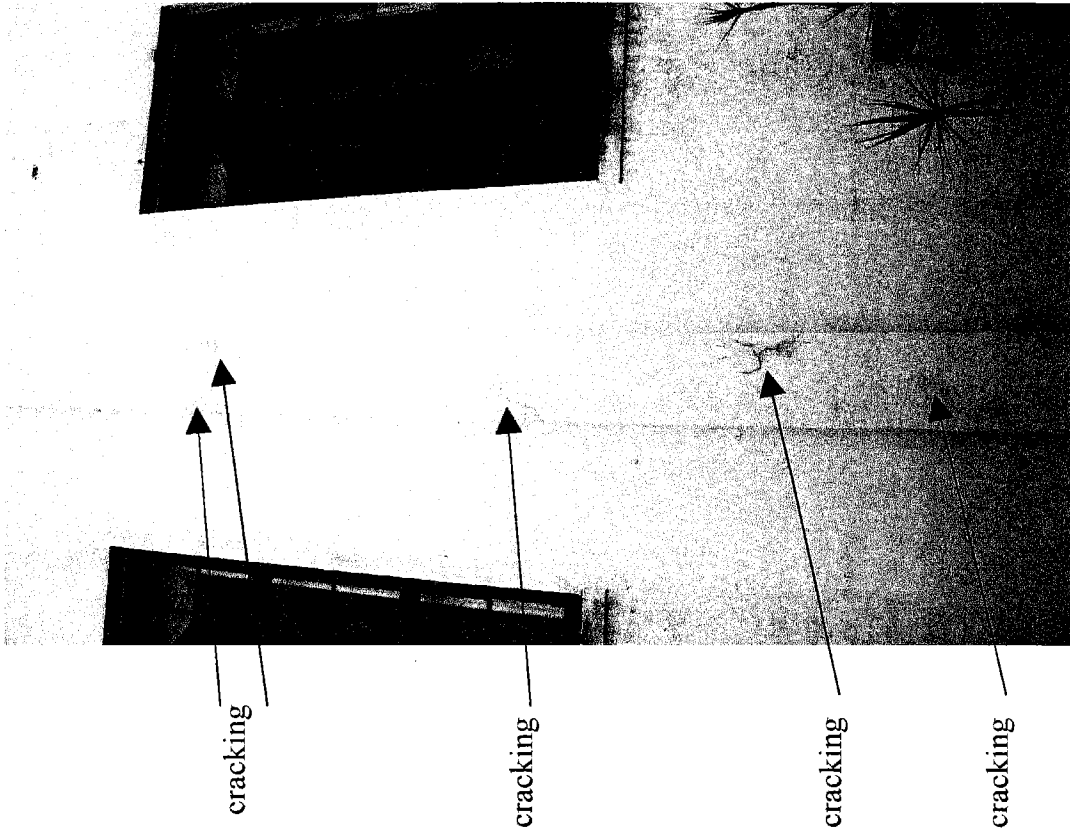
CRACKING OF CONCRETE AT PILASTER

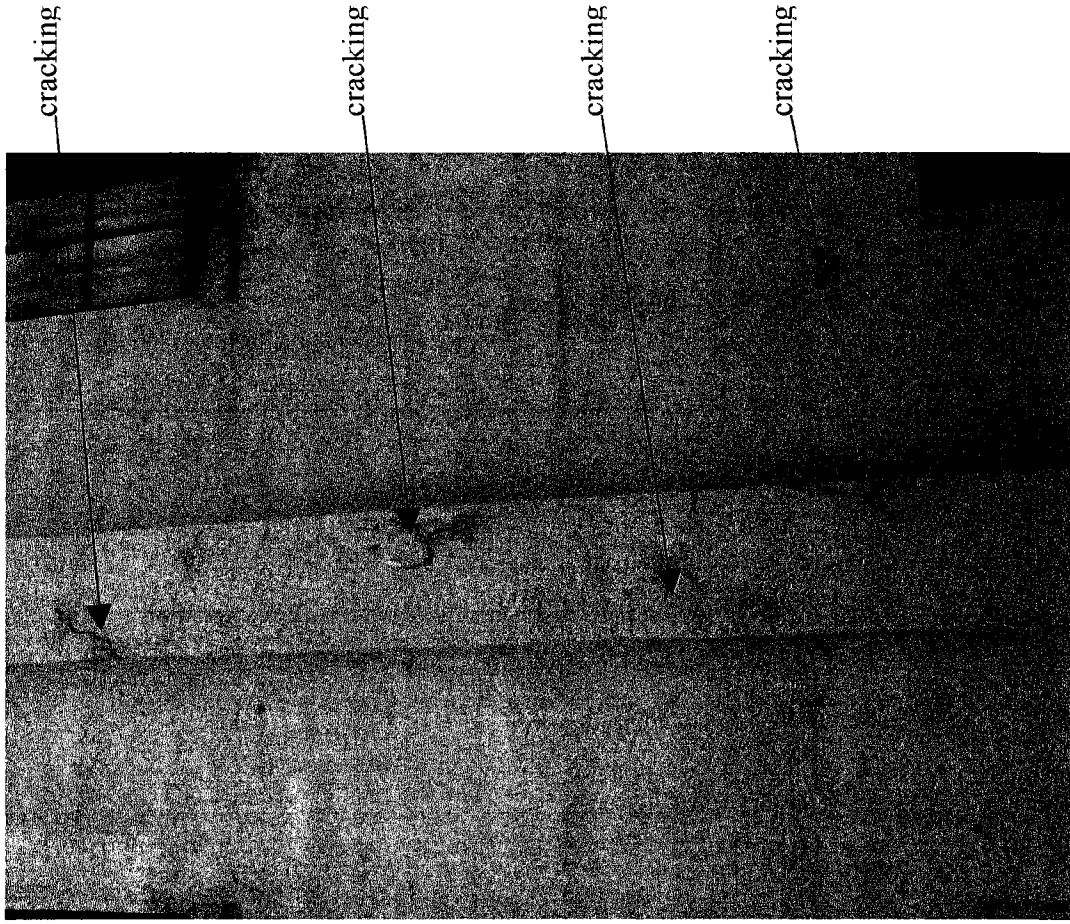
CRACKING OF CONCRETE AT PILASTER

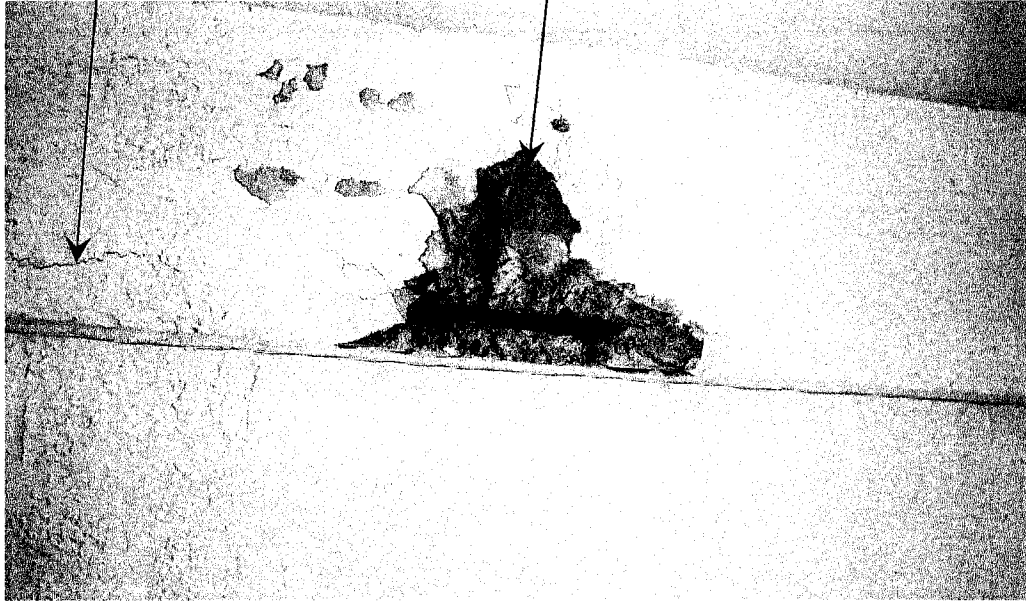
SPALLING OF CONCRETE AT PILASTER

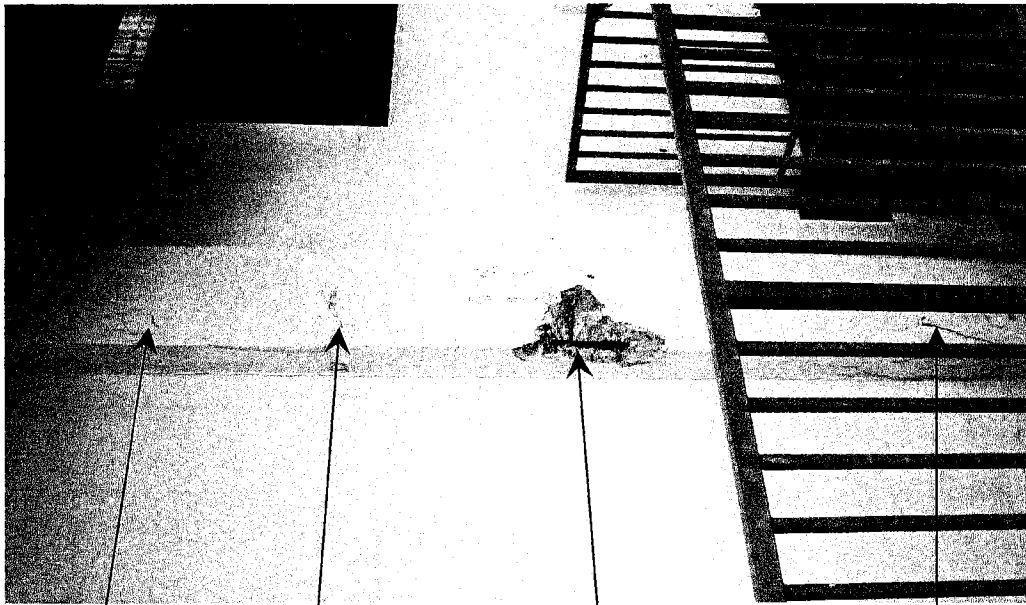
SPALLING OF CONCRETE AT PILASTER

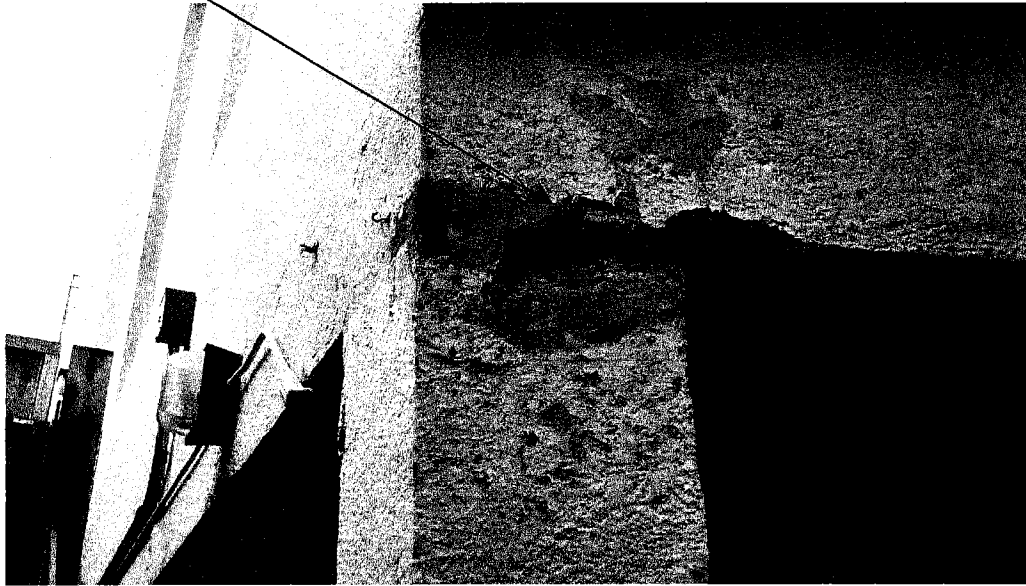
STAGE ADDITION CONCRETE COLUMN SPALLING

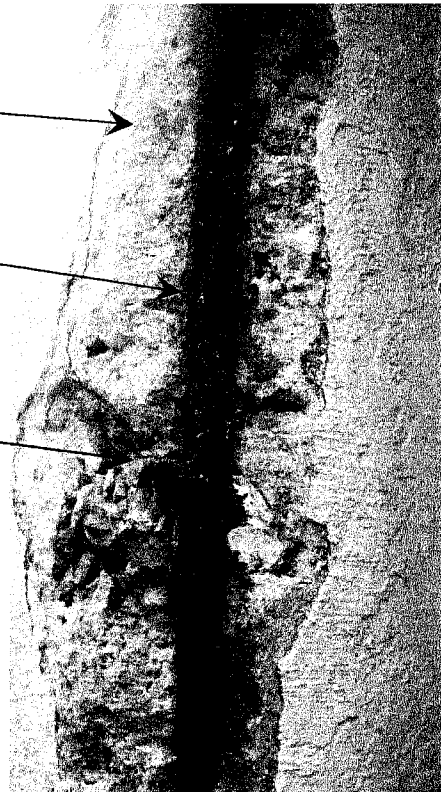
STAGE ADDITION CONCRETE COLUMN
SPALLING AND REINFORCEMENT CORROSION
